Aztech Environmental

October 10, 2019

RE: Sub Slab Depressurization System Verification

510 Furnace Dock Road

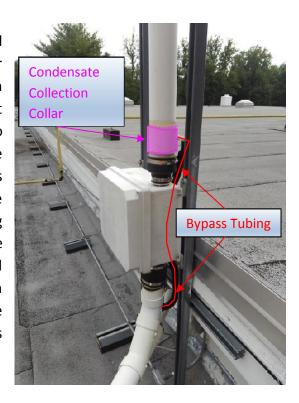
On July 11, 2019, Aztech personnel visually inspected the three (3) effluent stacks and the potential for condensate to escape the system. Upon inspection of the effluent stacks, liquid condensate was not observed at any of the three (3) effluent stacks. To prevent any condensate escaping the system in the future, a small diameter "bypass" tubing was installed to route liquid condensation from above discharge of the fan to the extraction header piping below intake of fan (refer to photograph). The extraction piping is pitched so that accumulated liquid will be transported back to the extraction points. The condition of the "bypass" tubing will be documented during the future annual inspections and will be replaced as needed.

Field observations and applied vacuum measurements from the July 11, 2019 site visit indicated that liquid condensate was not being generated during the time of inspection. In order to mitigate the potential discharge of liquid condensate, Aztech installed condensate "bypass" tubing that will route any condensation back into the extraction header piping. The applied vacuum measurements collected on July 11, 2019 visit demonstrate that the SSDS is applying sufficient vacuum to extract vapors from beneath the sub-slab. .

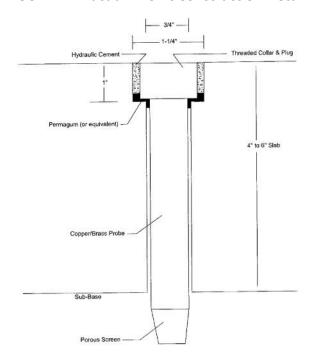
FIGURE 2 - Vacuum Point Construction Detail

On the same date, Aztech installed five (5) vacuum monitoring points at pre-designated locations across the southwest portion of the concrete floor located at the Site. The five (5) newly installed vacuum monitoring points ranged from 16 feet to 38 feet from the nearest vapor extraction well. Please refer the attached **Figure 1 – SSDS Layout**. **Figure 2** (page 3) shows the typical construction of a vacuum monitoring point.

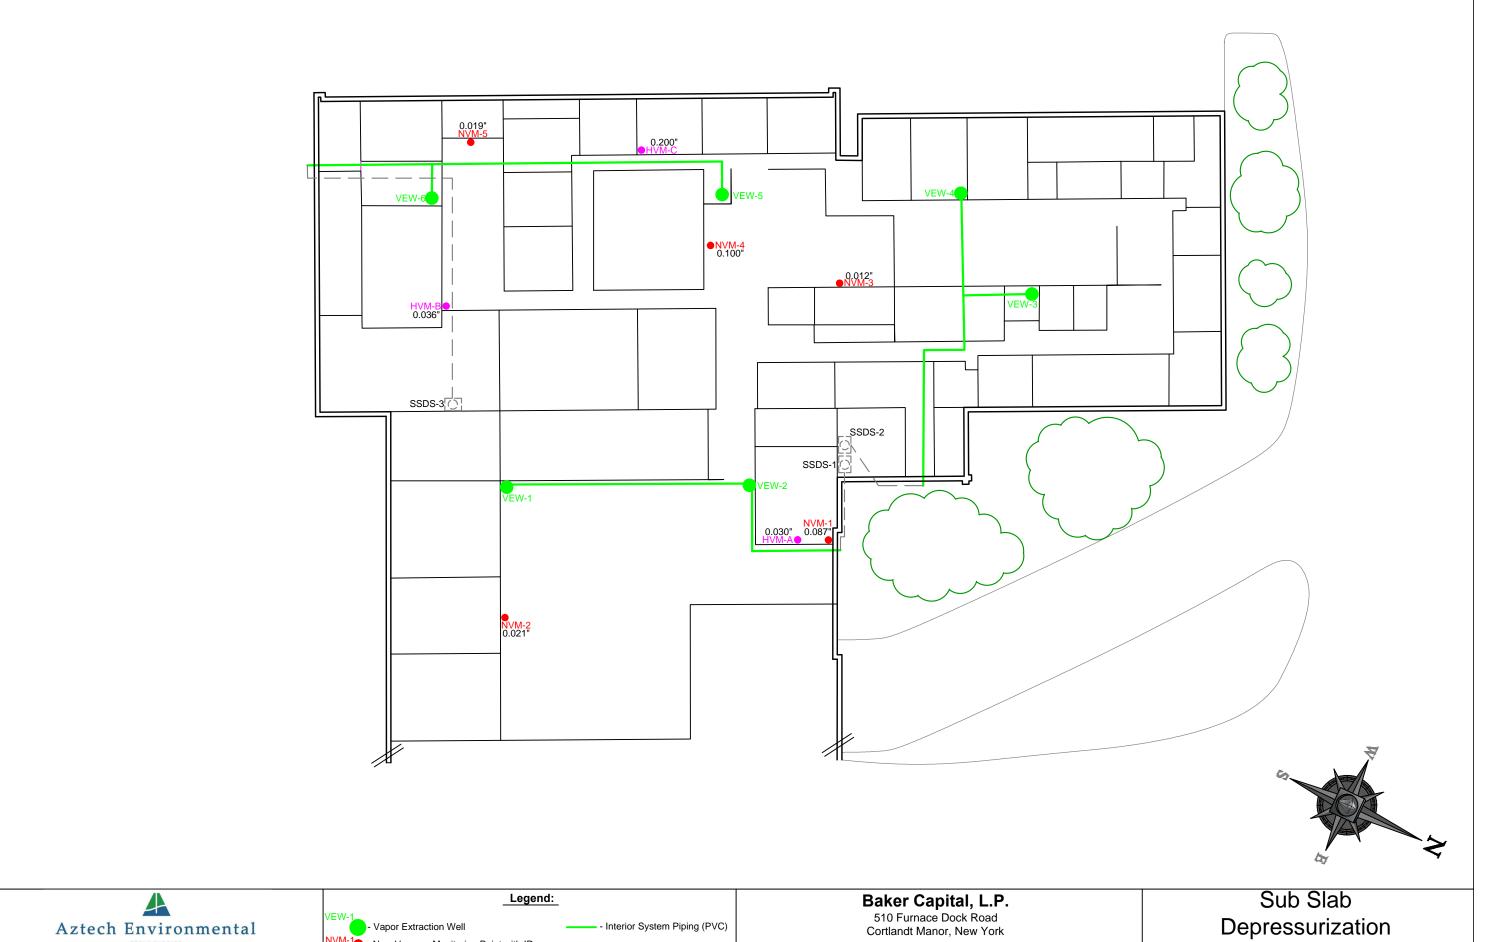
FIGURE 1 DATE: July 11, 2019 SCALE: Not To Scale System Layout July 11, 2019

Subsequent to the install of the five (5) vacuum monitoring points, Aztech used a micro manometer capable of measuring applied vacuum to 0.001 inches of water to measure the vacuum generated by the SSDS. The applied vacuum ranged from 0.012 inches of water to 0.100 inches of water. These measurements are above the 0.004 inches of water column, as required by the NYSDOH, thus confirmed that the system is generating sufficient vacuum to collect and expel any vapors emanating from beneath the concrete floor.

Additionally, Aztech located 3 historical vacuum monitoring points. Applied vacuum

measurements from these monitoring points ranged from 0.020 inches of water to 0.036 inches of water. These readings further confirm the effectiveness of the vacuum generated by the system.
